To what extent can an archaeological study of St. Luke's and All Saints Church, Darrington contribute to our understanding of the development of the site?

Rachael Wilkins

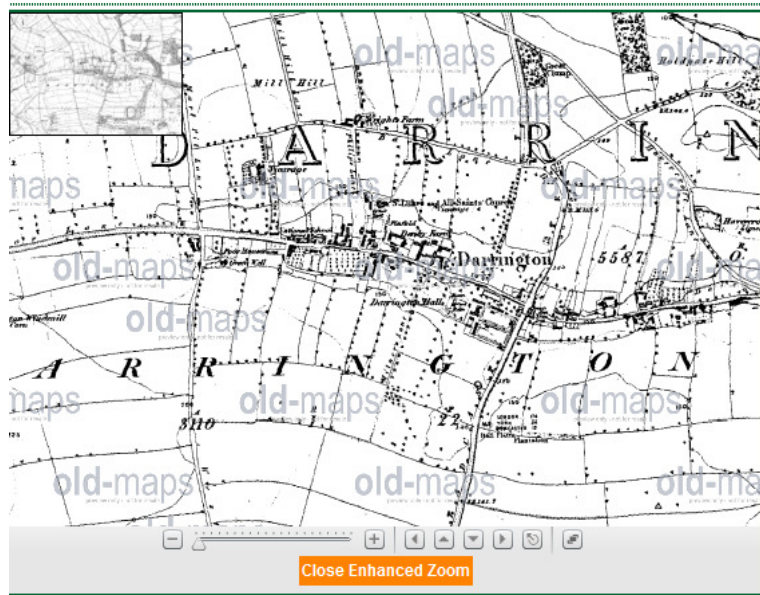
Fig 3, taken from www.old-maps.co.uk showing Darrington 1852-53³

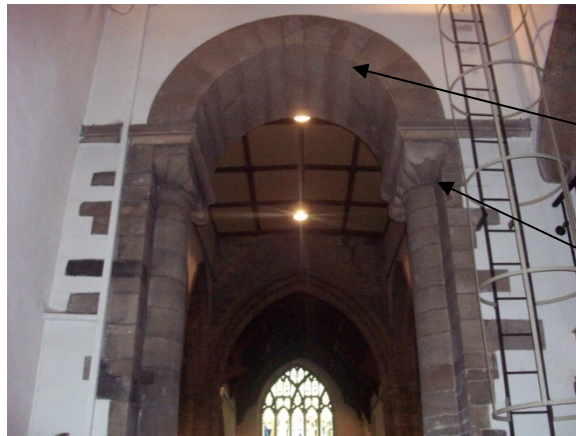
Arch

Scalloped capitals

Fig 8 taken by me 29/12/10 showing the entrance to the nave with the scalloped capitals and abaci

The tower opens to the nave; originally, by a very narrow arch part of which you can still see on shafts with scalloped capitals and abaci, but a larger arch has, been opened above it⁹.

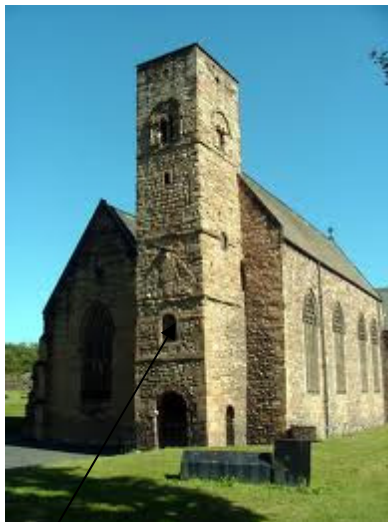
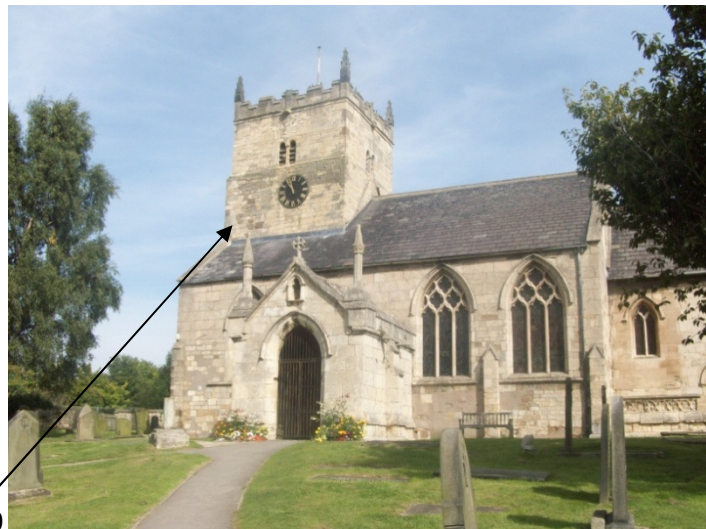
Fig 9

Fig 9A- taken from Google images showing the Saxon tower of Jarrow compared with the different tower layout of Darrington Norman tower taken by me 23/11/10

We know the Tower is later than its foundations because if the Tower was Anglo Saxon it would look more like the Saxon tower at Jarrow Church which is positioned and looks different from Darrington Church Tower (fig 9 and 9A).

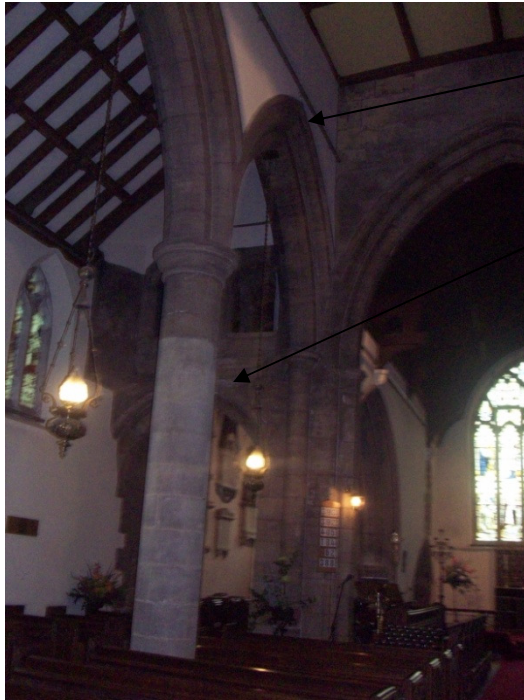
Chamfered points

Circular piers

Fig 13 taken by me 11/11/10 showing the arches of the North aisle showing the columns and chamfered points

The arcades are from the Perpendicular period, with tall circular piers and double-chamfered arches ¹⁰(Fig 13). We know this not only from the documentary evidence but also from typology as the same type of architecture is seen in Womersley Church, North Yorkshire where the arches are from the same period.(Fig 14) Each aisle measures 97 m X 84m.

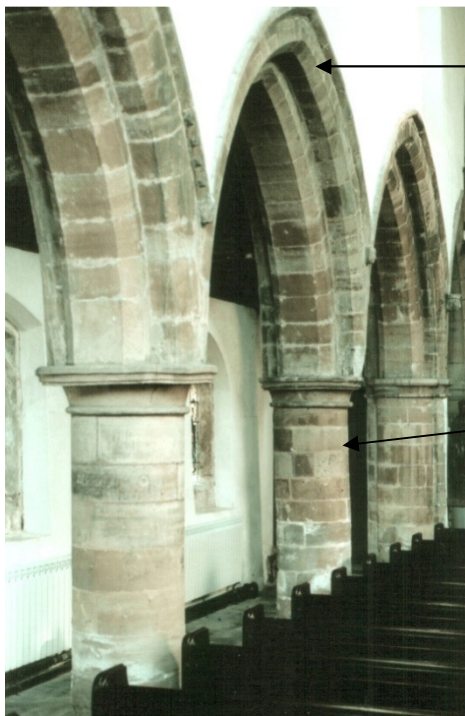
Fig 14- arches in Womersley church; St Martin's which are very similar in type to the ones at Darrington¹²

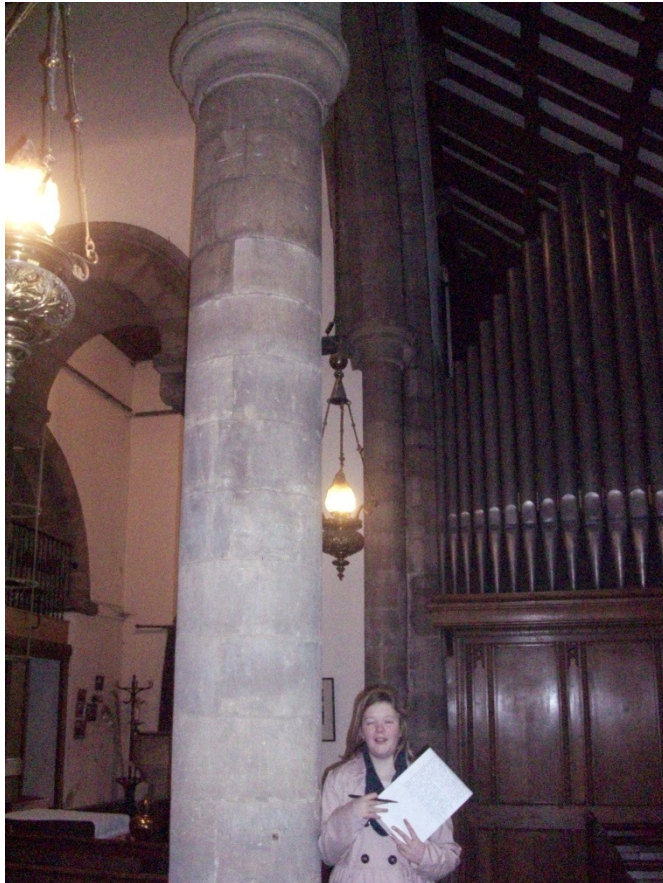
Fig 15-taken by me 22/2/11, close up of tall circular columns, with my sister, who is about 1.53m tall.

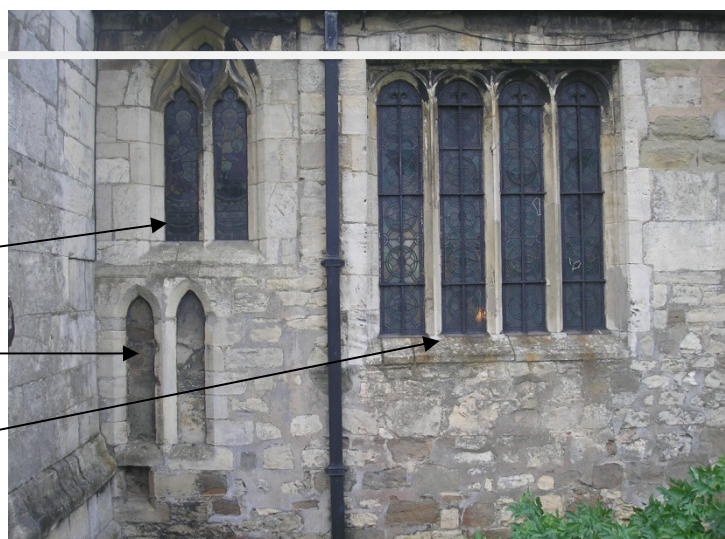
Fig 16 taken by me 11/11/10 shows the blocked window from the outside, the different window types within the North aisle and the medieval roof heightening

- Decorated windows
- Blocked window
- Perpendicular window

At the northern end of the north aisle there is some evidence of lowering of the floor as four courses of brick were found at the foot of the wall¹³. There is another blocked window that has been filled in with rubble near the east end of the north aisle.

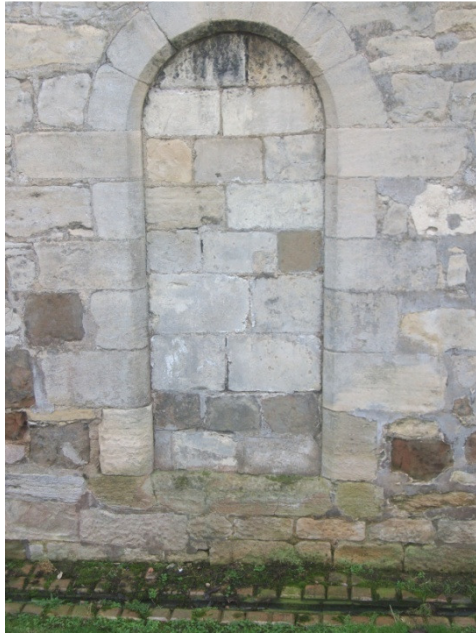
Fig 17 taken by me 22/2/11 showing the blocked door

Pevsner concludes that the aisles embrace the tower and that they were first built during 13th Century, and you can tell this through the West lancet, the North doorway (now bricked up) and the arcades¹⁴. The fact that Pevsner suggests that the blocked up doorway is in fact just a 13th Century feature suggests that the rumours of it being used for the lepers during this period is incorrect however, that doesn't mean that it couldn't have been used for that purpose later on fig 17.

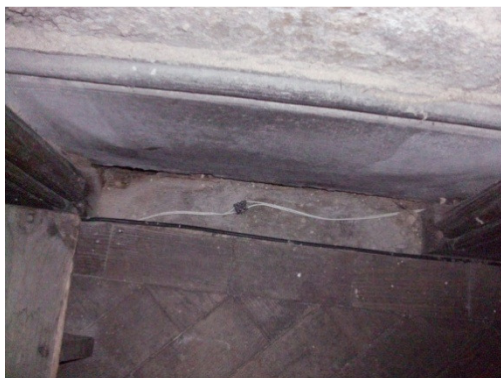
Fig 18 taken by me 22/2/11 showing the floor where there is evidence of floor lowering

Later during the repairs needed for damages occasioned by mining in 1994 Peter Ryder found that: The west wall of the south aisle showed medieval heightening and floor lowering (Fig 18), however there is new stone over of much this evidence which makes it difficult to see. Four sockets were found at a lower level and two sockets were found just below the ceiling, suggesting a former wooden staircase which leads to the gallery or tower¹⁵.

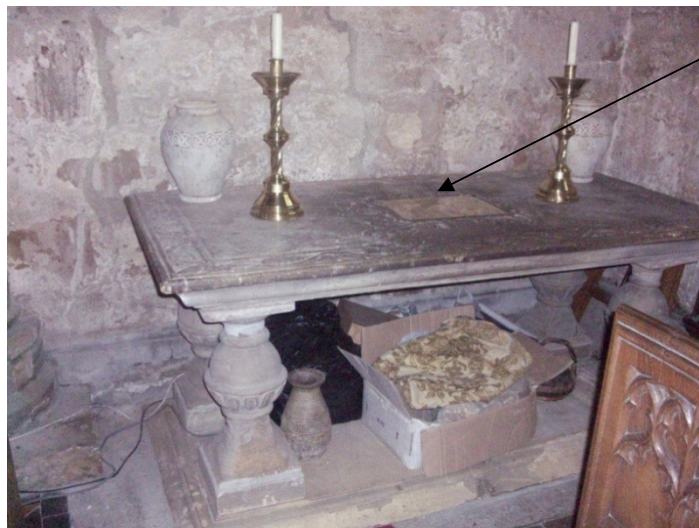
Alter tomb stone of William Farrar, died 1684, and was used as the communal table until 1880

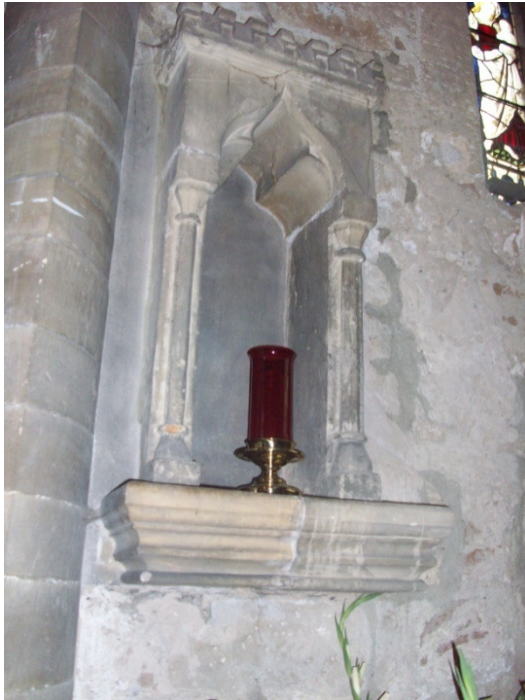
Fig 21 taken by me 23/10/10 showing the South aisle piscine which was used during mass for washing before being put before Christ

Stephen Glynne states that the South aisle used to have in the East end a “single lancet with a pretty piscine underneath surmounted by a horizontal battlement...and set on a moulded projecting ledge”¹⁷.

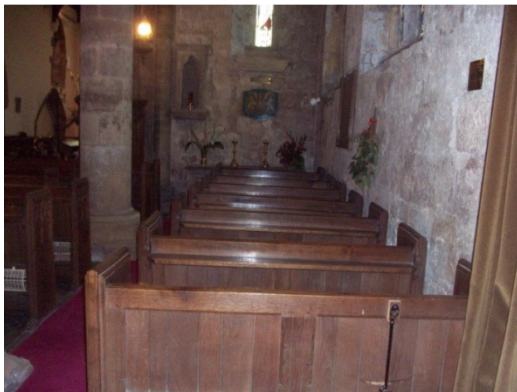
Fig 22 taken by me 23/10/10 the South aisle

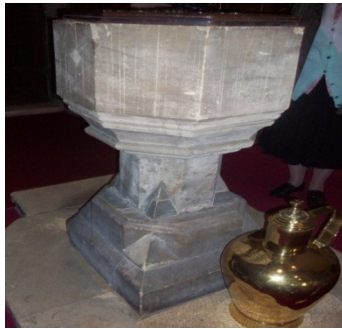
Fig 26 taken by me 29/12/10 showing the ancient font

The font is central to the West entrance and has been for circa 700years.

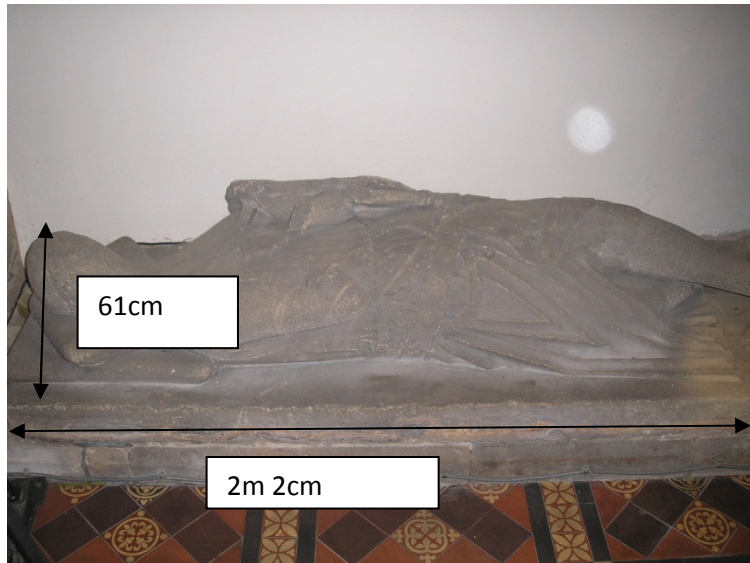
Fig 28 taken by me 11/11/10 Sir Warren de Scargill circa 1330 her husband measures 2m 2cm X 61cm.

The North chapel, or more commonly known as the Lady Chapel (fig 29), holds one of the two effigies in the church. It is suggested to be the effigy of Lady Clara de Stapleton, 1326, (Fig 27) separated at death from her husband on the other side of the wall (fig 28). Effigies are found in most churches demonstrating that they are highly important individuals as they are inside the church.

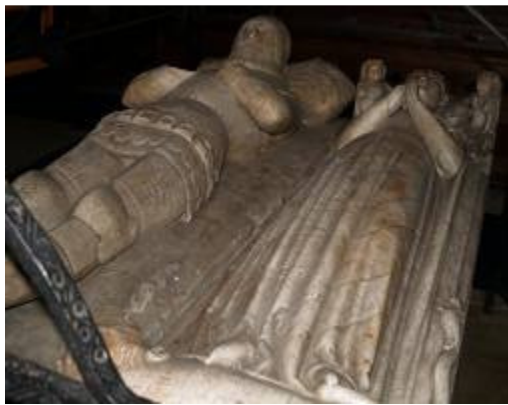
Fig 28A taken from Google¹⁹ showing the effigies at West Tanfield, North Yorkshire, interestingly are not separated in death like the ones at Darrington

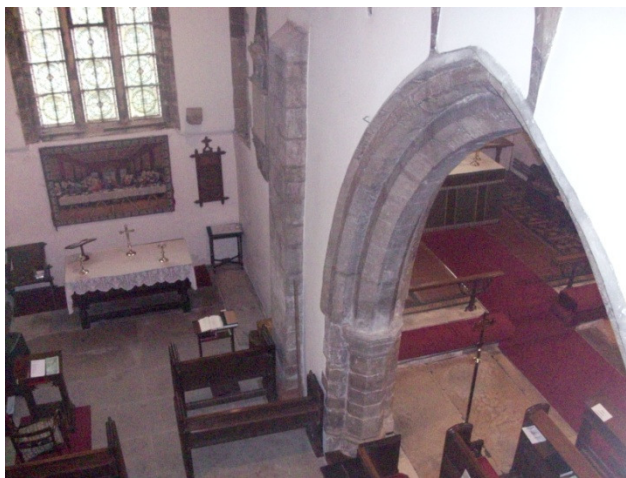
Fig 30 taken by me 22/2/11 showing the chapel from the gallery

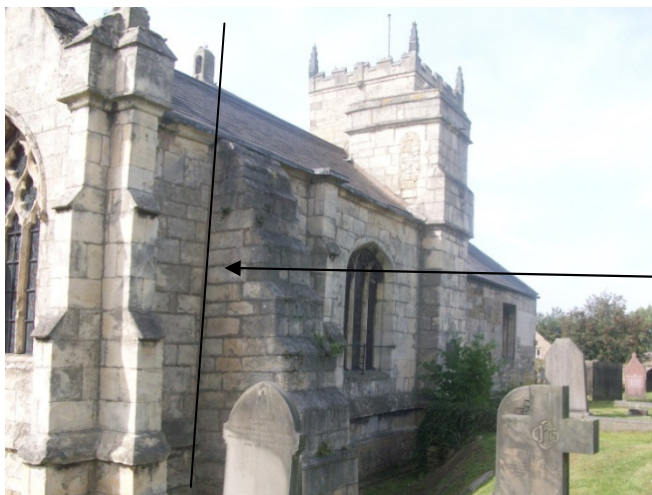
Showing the abutment
to the church

Fig 31 taken by me 23/10/10 shows the abutment of the buttress to the wall showing it was added later for strength

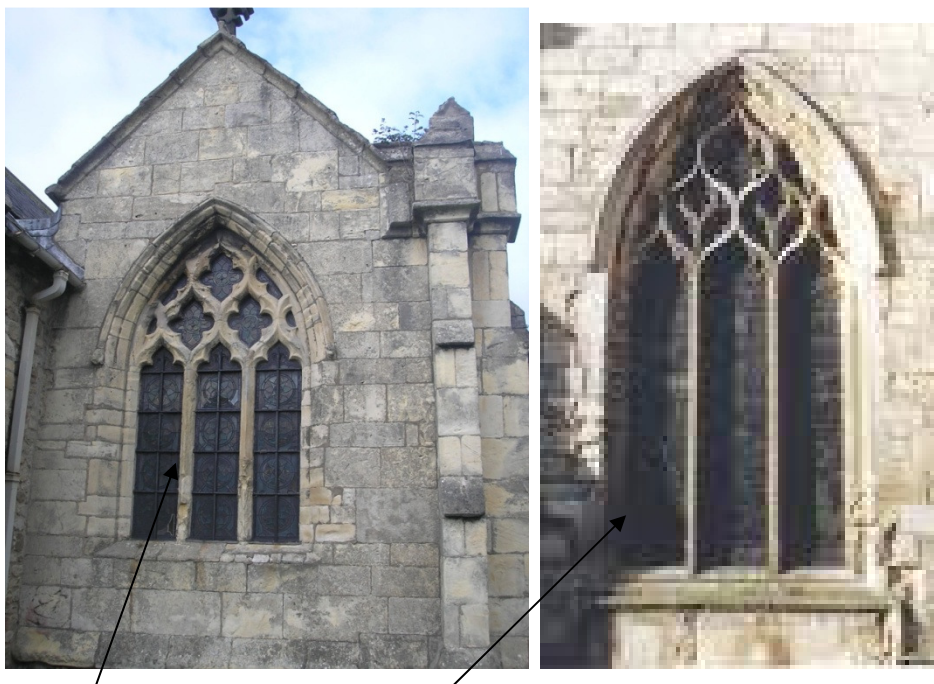
Fig 33 (Darrington church) and 33A (St. Martins) taken by me 23/10/10. The East window is Decorated (1300-1350), of three lights. We know it is from this period as other churches from this era have the same style windows such as Womersley church, St Martin's North Yorkshire

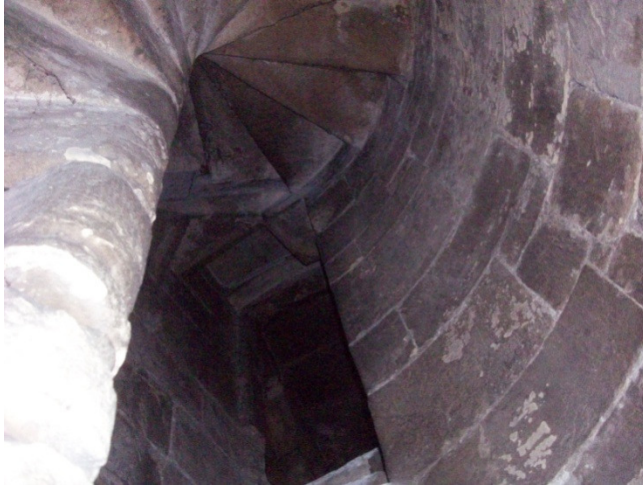
Fig 34 taken by me 22/2/11 showing the stairs to the rood loft/gallery inside the lancet

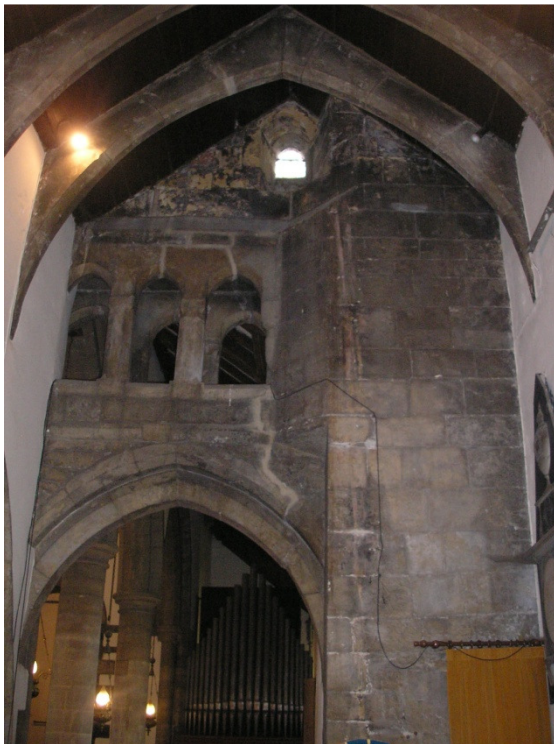
Fig 35 taken by me 11/11/10 showing the gallery

Over entrance to the North chapel is one unique gallery positioned between the North chapel and the aisle, with three arches opening from it on either side. The reason for it may have been that it had a connection with the rood-loft²². (Fig 35)

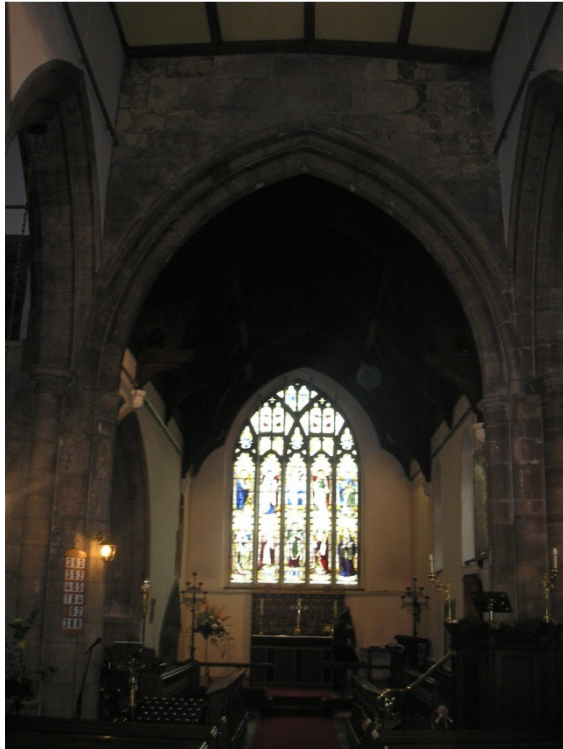
Fig 38 taken by me 23/10/10 showing chancel arch and five light window

The Chancel is dated to the late 13th/ early 14th century, however the exact date is uncertain as it includes mostly perpendicular features²³. The interior of the chancel is mostly made of coursed squared limestone²⁴ and at the East end of the chancel there is no dressed stone. The chancel arch is pointed on octagonal columns with capitals; the East five light windows are Perpendicular.

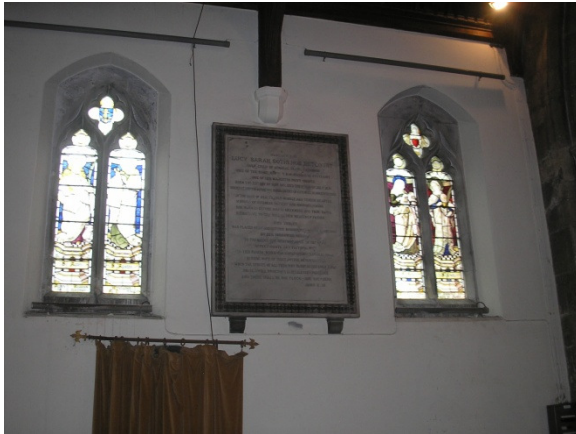
Fig 41 taken by me 22/9/10 showing the Perpendicular windows in the southern wall of the chancel, where it is suggested that they were formerly Decorated windows²⁵.

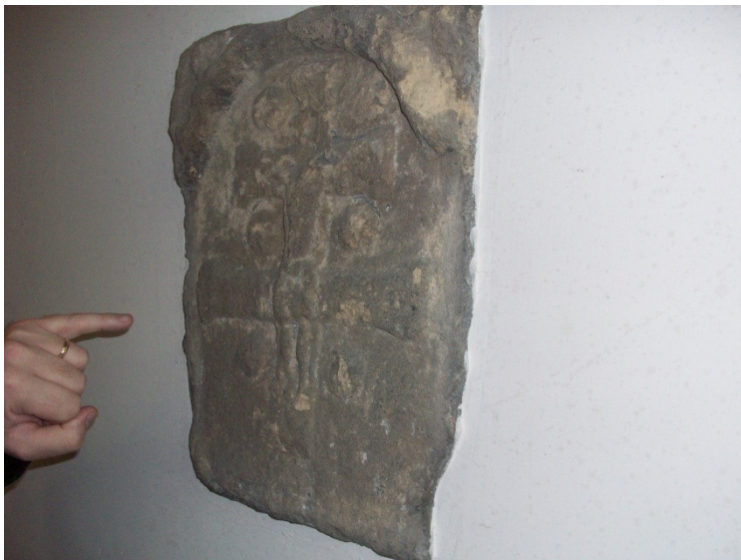
Fig 42 taken by me 11/11/10 shows part of the uncovered artwork in the chancel

J.S Fletcher tells the story of how this piece of exquisite artwork, circa 1200, came to be part of our church. Canon Atkinson found the artwork in a garden wall in Cridling Park. The relic is made of sandstone and was eroding and so he took it and placed it in the East wall of the South aisle, but is now situated in the north wall of the Chapel. It was examined by Mr. Richard Holmes of the Journal of the Yorkshire Archaeological Society, 1891, who states “the writer considers it [the crucifix] to be unique...the whole would form a double cross similar to that of the Order of the Holy Sculpture...” J.S Fletcher goes on to say that “Darrington Church, therefore, may safely claim to possess at any rate one English antiquity that is unique-no particulars of any ancient sculpture and archaeologists”²⁶ see fig 42.

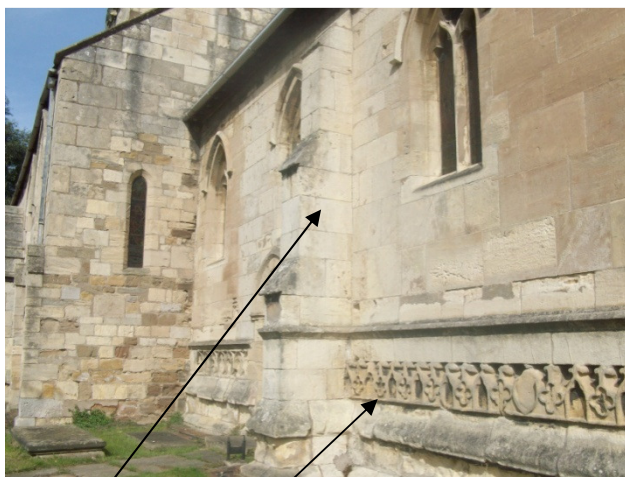
Fig 44 taken by me 26/08/10 shows the

stepped buttress and decorative frieze which is atypical of a church and could have been done by village specialist craftsman

Externally, the chancel, like on the inside is built of well squared limestone blocks and a stepped buttress midway along the south wall²⁷.

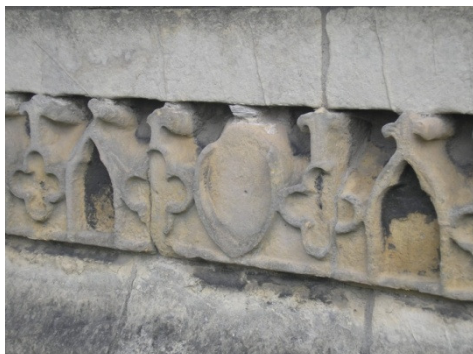
Fig 45 taken by me 26/08/10 the decorative frieze

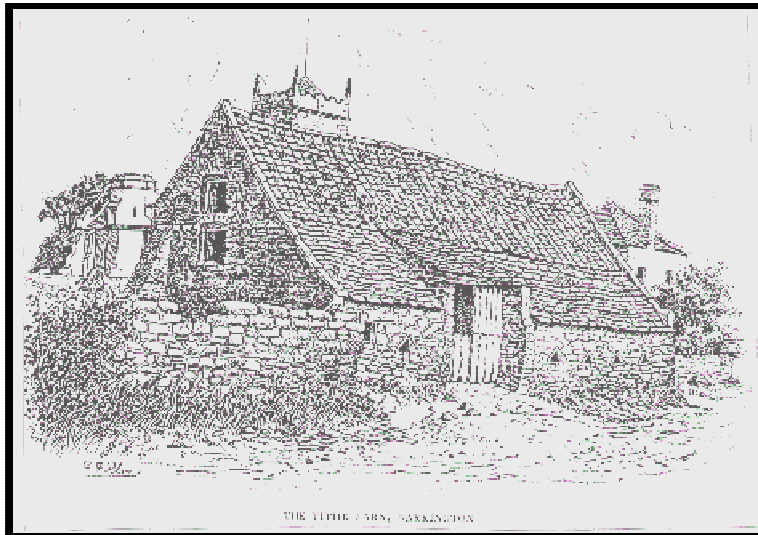
Fig 48- showing a sketch of the

Tithe Barn by G.P. Rhodes featured in J.S Fletcher book. The Darrington Website gives a good description of what the tithe barn may have looked like: The Early Medieval building may have had five bays, the roof was built of stone tiles (we know this because if the roof was thatched the roof would have had a steeper pitch) and stone walls (which is evident from the structure that is left)²⁸.

The tithe barn, built in Early Medieval period, was owned by the vicar and was relied upon in a predominately agricultural community for supplies during tough seasons.

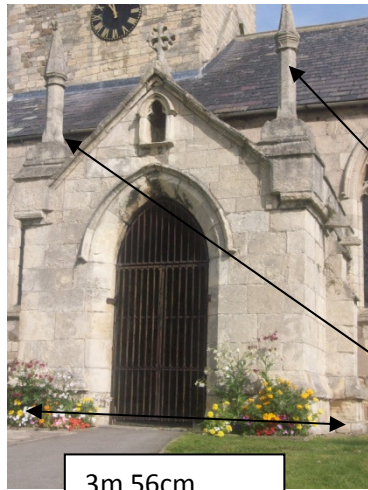
3m 56cm Fig 49 taken by me 26/08/10 shows the octagonal pinnacle with square bases, hooded mould and chamfer.

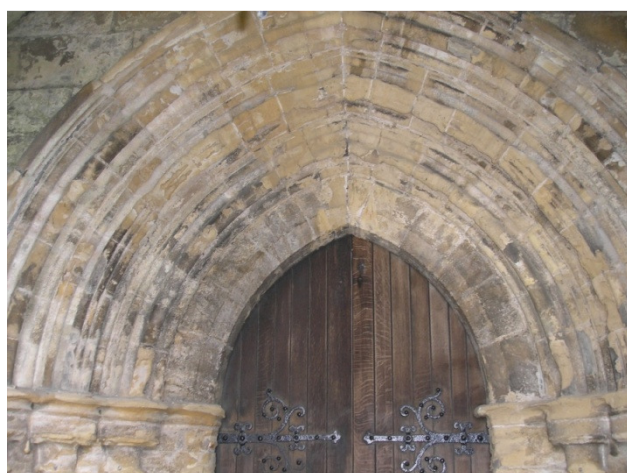
Fig 51 taken by me 22/2/11 showing the pointed arch above the porch door which is not typical of a church

Internally the south door is encompassed in a pointed arch that has chamfered jambs with three richly moulded imposts.

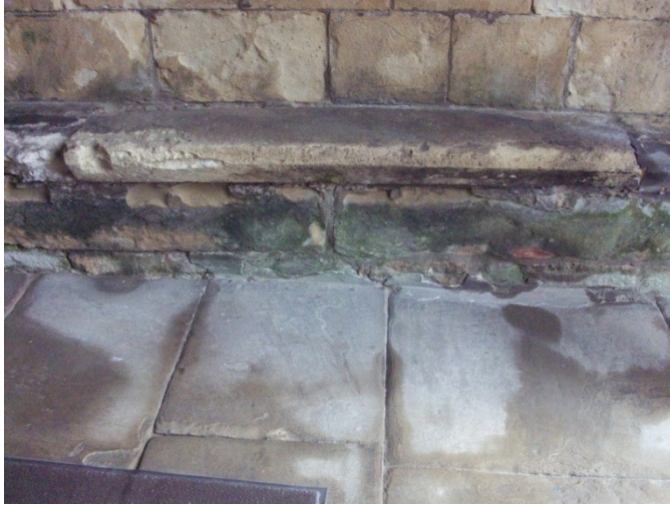
Fig 52- taken by me 31/10/10 showing the stone benches suggesting medieval corpse slabs³¹ measure 3m 23cm X 54cm.

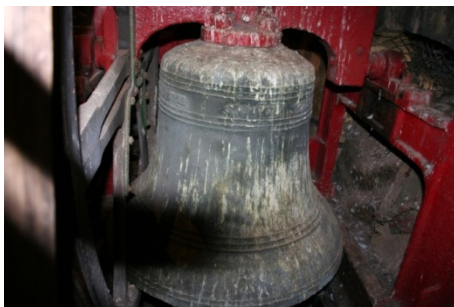
Fig 55 taken by Paul Stainer, 2010, showing the one of the bells in the tower

After the Black Death in 1350 a new bell tower was added to the top made of squared blocks of limestone. This was built by Warren de Scargill and his lady wife Clara de Stapleton. J.S Fletcher describes how they furnished this new part of the tower with three bells, one dedicated to St Michael³².

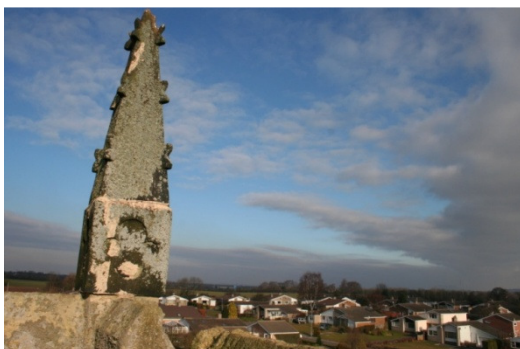
Fig 57 taken by Paul Stainer, 2010, showing one of the four pinnacles in detail if somewhat precariously perched

The tower also suffered some damage during 19th century, in a history of the church, Author Unknown, Date approximately 1980s it describes how, during Canon Atkinson's era (1892-1928); on 22nd December 1894 the south east pinnacle of the tower fell onto the roof of the nave. It was repaired and a new bell was fitted in 1895 and in 1896 two other bells were fitted making a peal of six³⁸. This could explain the new roof tiles and the different brick at the top of the church.

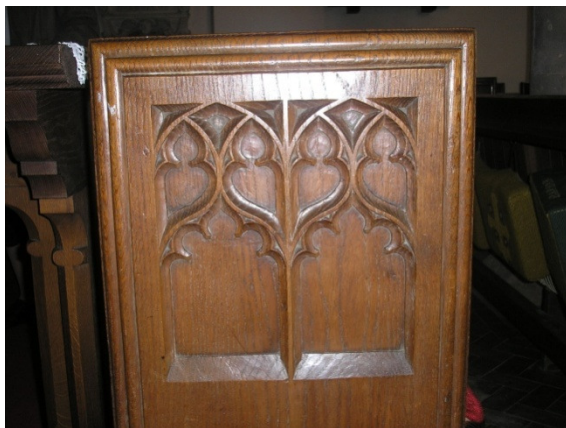
Fig 58 taken by me 23/10/10 showing the decoration on the side of the pew which looks similar to the decorated windows

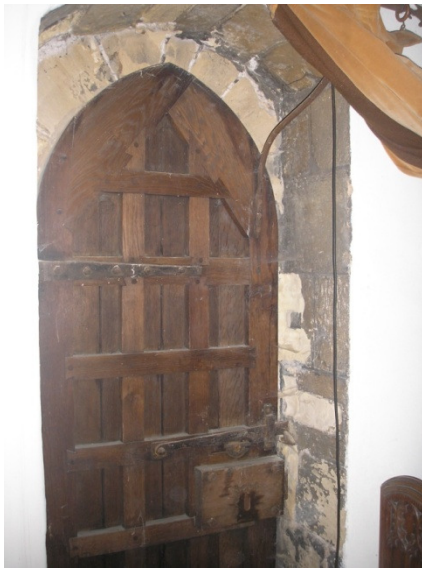
Fig 59 taken by me 11/11/10 showing the bishop's door that was found in a pig sty

J.S Fletcher gives a good description of the restoration, courtesy of Reverend Wrangham, that took place during the 1875-80 at the cost of £2500, which seems a small cost; however most of the work to the church was given as gifts in memory of a loved one keeping the costs low, other features were found littered around the village such as some of the stained glass was found during the restoration on the floor behind the church by Mrs Hope Barton. This was then used to make the North window we see now; however some was missing so was filled in by unwanted glass from other churches. A passer by casually walked off with some valuable old brass which he kept for ten years before giving it back and, the chancel door was found in a pig sty after it had been stolen before its restoration in 1875³⁵.

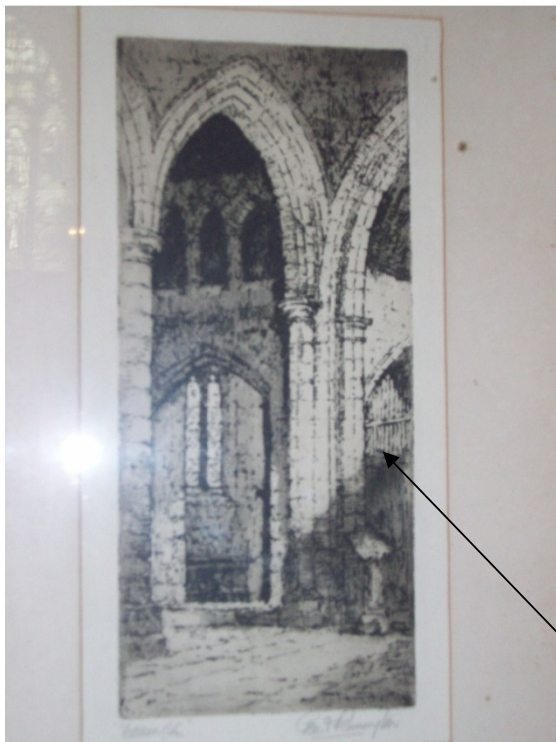
Fig 61 taken by me 11/11/10 shows the organ

where it was originally positioned.

The organ was originally installed in the North/Lady Chapel in 1875 forming a small vicar's vestry at the East End. J.S Fletcher mentions how Mrs Lee gave £500 for the organ, in memory of her father Mr Richard Thomas Lee, as well as an extra £180 to the church.

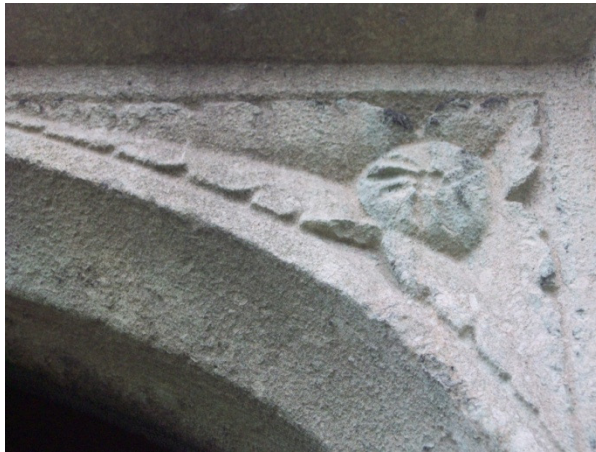
Fig 62 taken by me 22/2/11 showing the incised pattern on the right hand side of the outer door

Outside the tower there are the traces of an incised pattern belonging to later 19th century date on the door however, only on one corner as the matching pattern on the other side has been eroded, fig 62

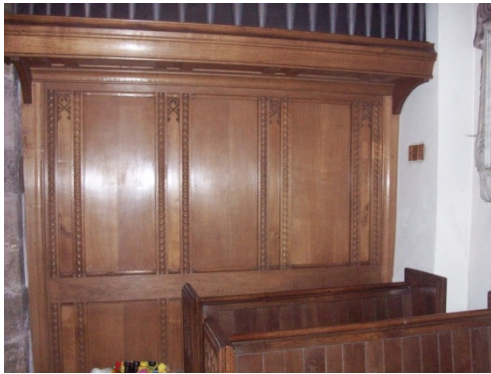
Fig 63 taken by me 22/2/11 showing the 1971 oak screen

In 1971 the organ was moved to the West end of the north aisle.³⁹ The vicar's vestry was formed behind the organ and a choir vestry was positioned at the west end of the south aisle with new oak screens, fig 63⁴⁰, which cost, in total, £5000⁴¹. This move coincided with the movement of the organ allowing the Chapel to be reinstated.

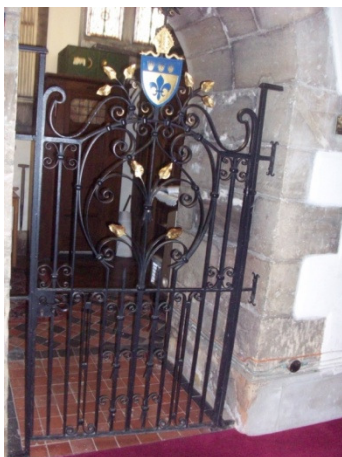
Fig 64 taken by me 22/2/11 showing the Vicar's vestry which was, in the 13th century, part of the North aisle
